Manhole Inspection Summary

Manhole # S07UU_001MH

Location Address: **REAR 3707 SPRINGDALE AVE** Cross Street: **CALLAWAY AVE**

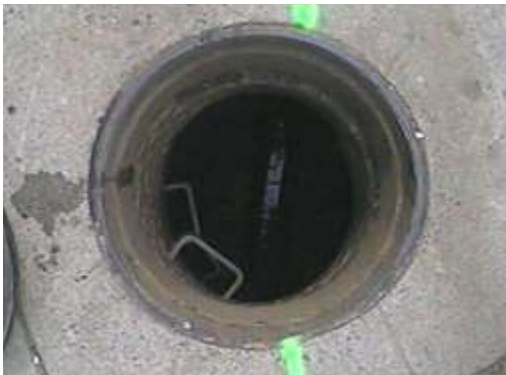
Defect 2

Frame Offset: **2** (in.) Condition: ☒ Sound ☐ Cracked ☐ Leaks

FRAME OFFSET

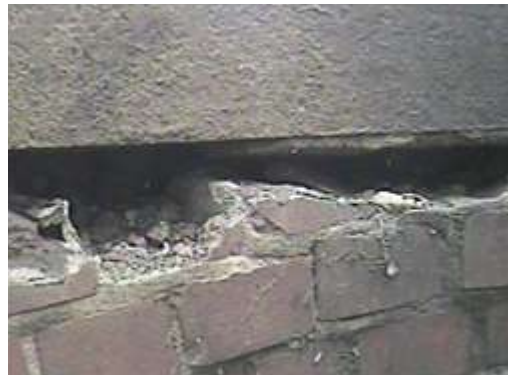
Defect 1

Condition: ☐ Sound ☐ Cracked ☐ Root Intrusion ☒ **Loose Brick** ☒ **Deteriorated**

DETERIORATED CORBEL-LOOSE
BRICKS

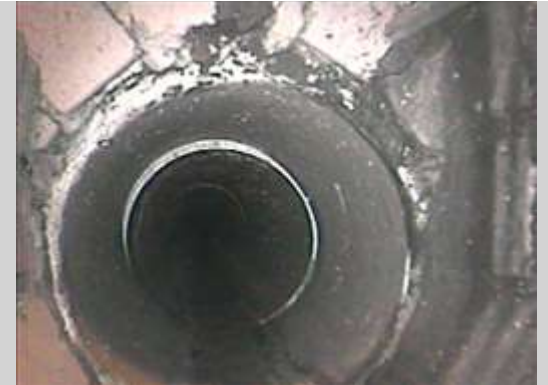
12 O'Clock Outflow

8 in. Circular Gravity Sewer
Pipe Out @ 12 O'Clock

Pipe Height: (in.) Direct
Pipe Material: **Clay** ☐ Pipe Lined
Invert Depth: **6.80** (ft.) Flow Characteristics: **Slow**
Deposits: ☒ None ☐ Mud ☐ Sludge ☐ Debris ☐ Grease
Silt Depth: (in.) Deposits Extent:
Infiltration: **None** Pipe Seal Cond: **Sound**

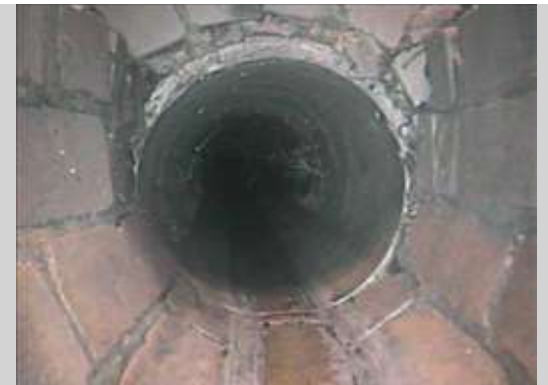
6 O'Clock Inflow

8 in. Circular Gravity Sewer
Pipe In @ 6 O'Clock

Pipe Height: (in.) Direct
Pipe Material: **Clay** ☐ Pipe Lined
Invert Depth: **6.80** (ft.) Flow Characteristics: **Slow**
Deposits: ☒ None ☐ Mud ☐ Sludge ☐ Debris ☐ Grease
Silt Depth: (in.) Deposits Extent:
Infiltration: **None** Pipe Seal Cond: **Sound**
